Navajo Abandoned Uranium Mine

Site Screen Report

Kinusta Mesa AUM Site

August 2010

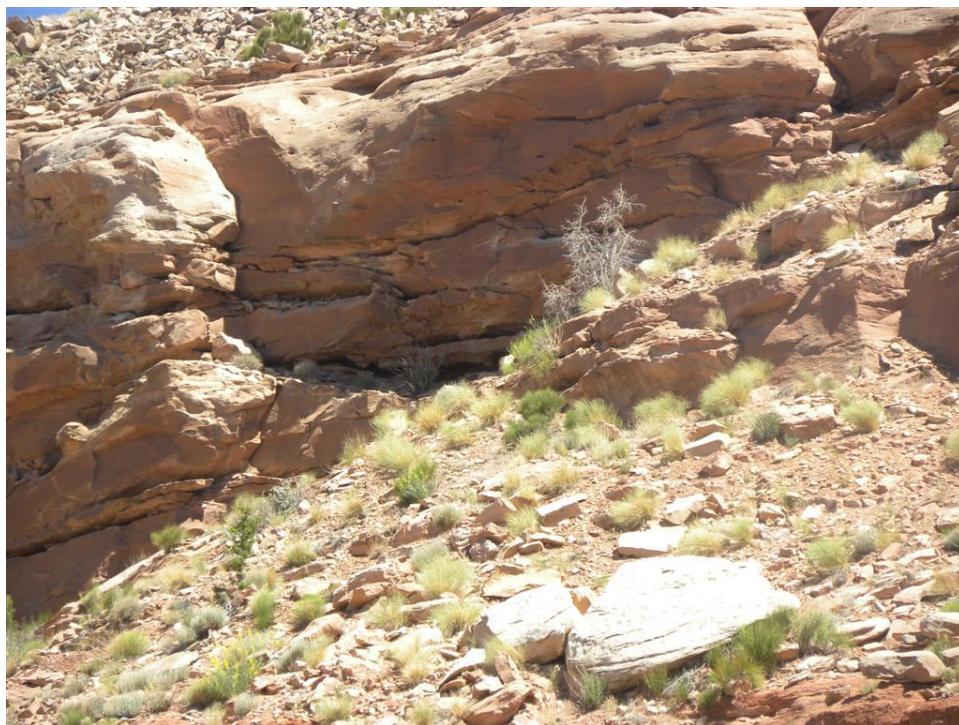
Photo 1. Kinusta Mesa site

Some ambiguous evidence of mining above cliffs with some possible waste, unknown
